DEPARTMENT OF TRANSPORTATION

Quality Assurance and Source Inspection

Contract #: 04-0120F4Cty: SF/ALA Rte: 80 PM: 13.2/13.9File #: 1.28**WELDING INSPECTION REPORT****Resident Engineer:**Siegenthaler, Peter**Address:** 333 Burma Road**City:** Oakland, CA 94607**Report No:** WIR-026063**Date Inspected:** 16-Aug-2011**Project Name:** SAS Superstructure**OSM Arrival Time:** 700**Prime Contractor:** American Bridge/Fluor Enterprises, a JV**OSM Departure Time:** 1530**Contractor:** American Bridge/Fluor Enterprises, a JV**Location:** Job Site**CWI Name:** Bernie Docena / Pat Swain**CWI Present:** Yes No**Inspected CWI report:** Yes No N/A**Rod Oven in Use:** Yes No N/A**Electrode to specification:** Yes No N/A**Weld Procedures Followed:** Yes No N/A**Qualified Welders:** Yes No N/A**Verified Joint Fit-up:** Yes No N/A**Approved Drawings:** Yes No N/A**Approved WPS:** Yes No N/A**Delayed / Cancelled:** Yes No N/A**Bridge No:** 34-0006**Component:** OBG Components**Summary of Items Observed:**

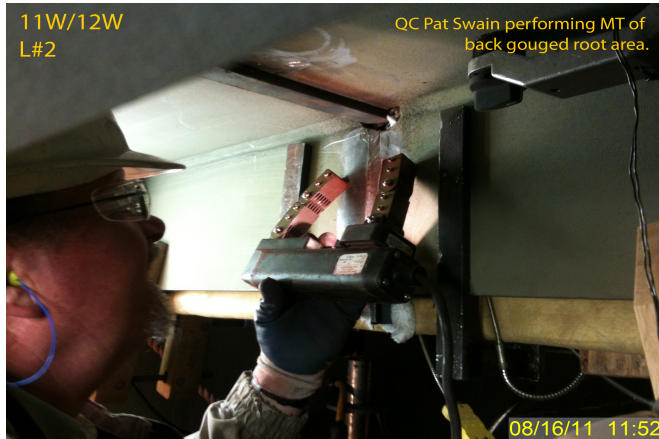
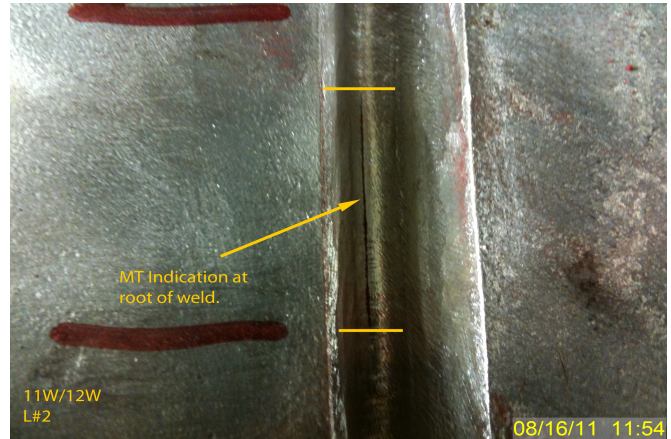
Unless otherwise noted, all work observed on this date appeared to generally comply with applicable contract documents.
